## **Correction of Frequent Maintenance Construction Assembly Error**

**See anything immediately wrong in the picture below?** This is a 5 plus inch Shaft and Pillow-block bearing on a Criticality 1 - Boiler I.D. Fan. If it doesn't run, the plant doesn't run! It Failed Frequently Until We Suggested a Simple Correction!

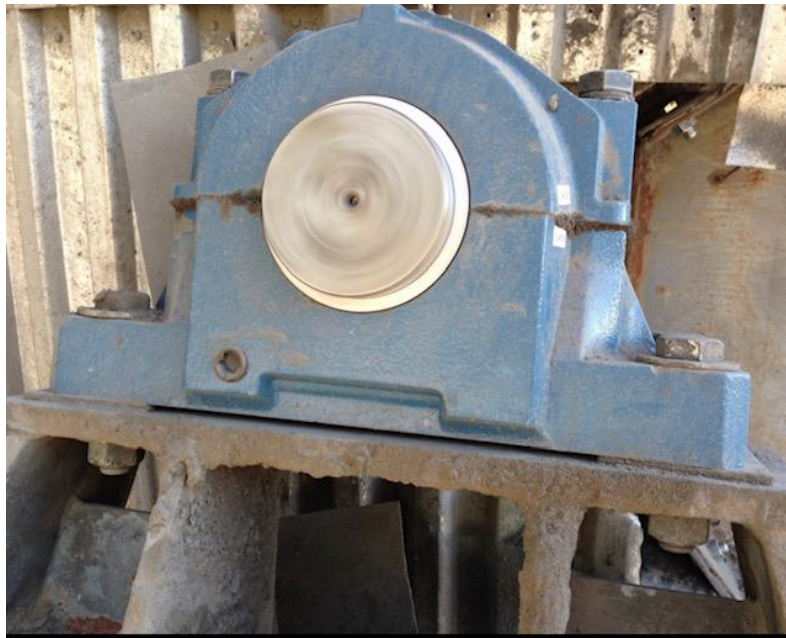
This bearing had an average life of 6 months to a year between random failures for many years. The plant had just "learned to live with it" Sometimes Vibe guys would catch it and schedule replacement, sometimes just sudden failure and downtime occasionally requiring expensive shaft replacement and 2 days downtime. The Bearing always ran hotter than expected 210-230F and the maintenance guys always pumped in More Grease #\$\$%!

**HINT ?** - I must admit, although I have preached and preached, I have failed miserably to get mechanics, engineers, and M&E mgrs. to understand, CAST IRON Housings Are Flexible, especially when submitted to multi-hundred, multi thousand-pound loads like fan rotors. See anything flexing?

**ROOT CAUSE?:** Most Bearing Manufacturers Installation & Maintenance Manuals, certainly this bearings mfr, SKF, Clearly Cautions, "Use a FULL FACE SHIM TO

SUPPORT THE HOUSING” The Bearing Pillow-block Housing is flexible enough under load it is "Pinching" the outer ring of the internal spherical roller bearing because the housing is

incorrectly shimmed on the bottom between the housing and the base. Look at those shims only supporting the 2 ends of the blue pillow-block housing.

What is happening in the center where there is no full face shim? As the Housing flexes, only 2 or 3 or 4 thousandths of an inch perhaps, pushing down on the outer ring of the roller bearing, it immediately takes the shape of the housing around it under the load. In this case the Ring responds in the only direction it can, pushing down on the "few" thousandths of original clearance, causing reduced bearing internal roller to rings clearance and thus accelerated friction, heat, lubricant breakdown and accelerated wear. You get the idea. VERY BAD! VERY BAD! Why is that occurring...

**Digging deeper, the Real Root Cause is the Common Habits** of most Construction and Maintenance Mechanics, All readily accepted by their Supervision, Engineers and Managers who allow it, if not Encourage it. They don't teach millwright skills in engineering school unfortunately and often management and supervision, pressed to make it run, "assume" their mechanics, also feeling the pressure to "make it run" know the correct thing to do. Those 2 – 1/8" metal shims under the housing? These are homemade from what looks like flat bar steel, a common practice throughout industry. but the same flexing takes place if they use more common and pre-cut stainless shims when trying their best to install the fan rotor and BOTH bearings Level to the Fan base. It's Ironic that while doing something admirable and craftsmen like, they create another yet worse problem. Bet you have heard that before huh!

**All we did to correct this issue was install a full face stainless custom shim that took all of 2 man-hours to find material and fabricate in their shop. Last time I checked, the bearing had NOT been changed in over 10 years!**

**Caution! First**, Correct and Communicate Specifications for Design, Purchase / Install AND insure all New Installs are done correctly. **Second**, identify any similar installs that bearings are not lasting and correct asap. "IF" you have good repair history, identify the ones that although incorrectly installed Have Never Failed (probably because they are more lightly loaded, bearing sizing, etc) For those DO NOTHING until a bearing has to be replaced. For those that have failed previously correct the shimming ASAP! **Third**, and most difficult, Set the Expectation with ALL mechanics, supervision and staff, we Will NOT create any more of these and every time we have to work on one previously incorrectly installed we will PLAN ahead and make the shim we need. We WILL NOT use smaller pre-cut stainless shims.
