Correction of Frequent Maintenance Construction Assembly Error

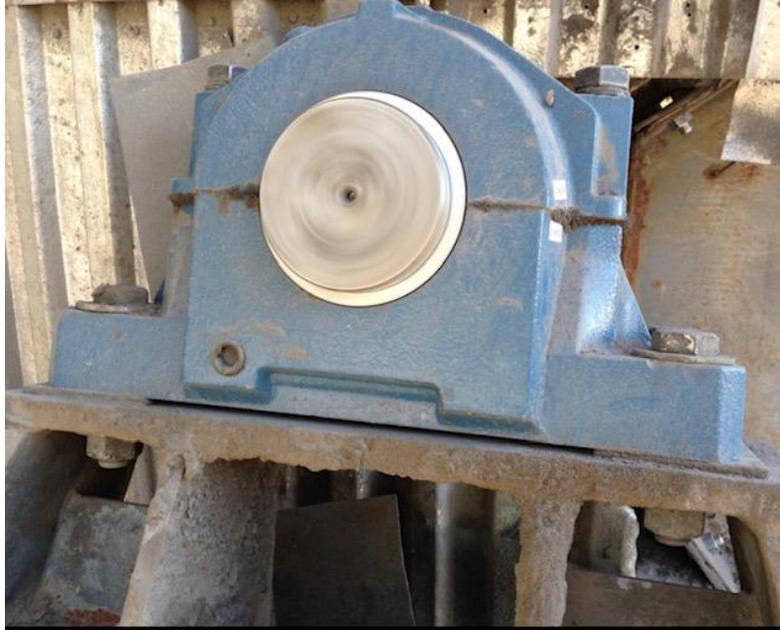
See anything immediately wrong in the picture below? It is a 5 plus inch Shaft and Pillow-block on a Criticality 1 - Boiler I.D. Fan. If it doesn't run, the plant doesn't run! And it Failed Frequently Until We Suggested a Simple Correction.

This bearing had an average life of 6 months to a year between random failures for many years. The plant had just "learned to live with it" Sometimes Vibe guys would catch it and schedule replacement, sometimes just sudden failure and downtime occasionally requiring expensive shaft replacement and 2 days downtime. The Bearing always ran hotter than expected 180-200F and the maintenance guys always pumped in more grease #\$\$%!

ROOT CAUSE?: Just to cut to the chase: The Bearing Housing is flexing under load and "pinching" the outer ring because it is incorrectly shimmed. Just a few thousandths of an inch, pushing down on the outer ring of the bearing which is, as every bearing engineer will tell you, EXTREMELY FLEXIBLE and immediately takes the shape of the housing under load. In this case the Ring responds in the only direction it can, pushing down on the "few" thousandths of clearance inside the bearing and reduces that clearance, causing accelerated wear, heat, you get the idea. Very Bad! Very Bad! Why is that Occurring?

HINT 2. The Real Root Cause is the Common Habits of most Construction and Maintenance Mechanics, AND their Supervision, Engineers and Managers who allow it, if not Encourage it and often "assume" their mechanics know what to do. See the 2 metal shims under the housing? These are homemade from what looks like flat bar steel, a common practice throughout industry. but the "real professionals" they make the same mistake with more common and expensive pre-cut stainless shims when trying their best to install the fan rotor and BOTH bearings Level to the Fan base. It's Ironic that while doing something admirable and craftsmen like, they create another yet worse problem. Bet you have heard that before huh!

Most Bearing Manufacturers Installation & Maintenance Manuals, certainly for this popular one pictured above, **Clearly Caution about NOT Creating This Problem** yet it exists in literally hundreds of thousands of Incorrect Installs. **The Manual Says, more or less, DO NOT Shim the Housing Without Using a FULL FACE SHIM TO SUPPORT THE HOUSING! Doing such will likely cause- Premature Bearing Failure. DUH !** All we did to correct this issue was install a full face stainless custom shim that took all of 2 man-hours to find material and fabricate in their shop. Last time I checked, the bearing had NOT been changed in 7 years!
